SERVICE PROCEDURE

15509

SUBJECT: SAFETY RECALL

LINEAR POWER MODULE (LPM) on certain AC and HC commercial bus, DuraStar®, LoneStar®, ProStar®, TerraStar®, TranStar®, and WorkStar® models built 10 January 2013 thru 10 March 2014 with the suspect LPM and on the same models built from 20 January 2010 through 31 December 2012 that may have had a LPM replacement with the suspect LPM.

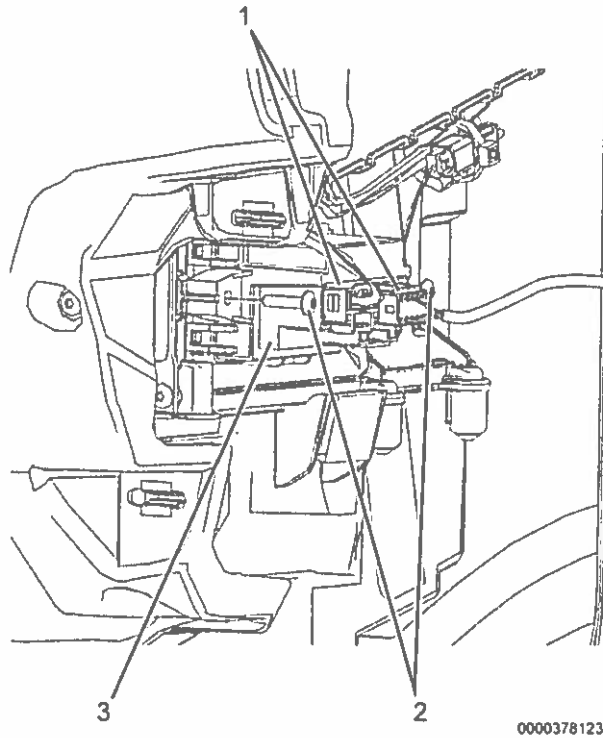
Figure 3. Linear Power Module.

A jump start or electrical load dump event could result in an overvoltage condition of the cab Linear Power Module (LPM). The overvoltage condition could eventually cause overheating of the LPM circuit board. Overheating of the LPM circuit board may cause a vehicle fire resulting in property damage, personal injury, and / or death.

11. Disconnect two LPM electrical connectors (Figure 3, Item 1).

12. Remove two screws (Figure 3, Item 2) securing LPM (Figure 3, Item 3), and remove LPM.

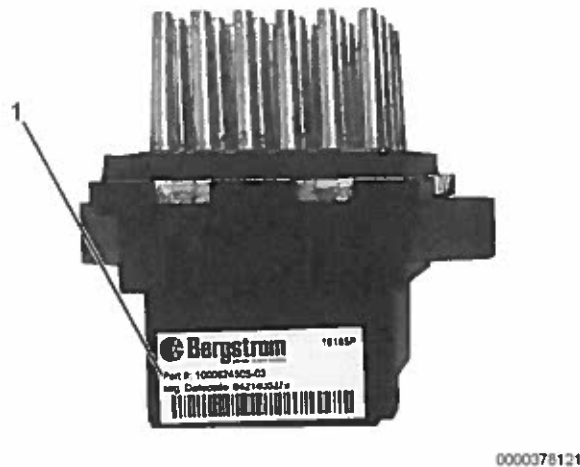
Figure 4. Linear Power Module Part Number Label.

13. Inspect the Bergstrom Part Number (Figure 4, Item 1) on top of LPM:

- a) If Bergstrom Part Number is 1000624505-XX, LPM does not require replacement. Reinstall LPM to interior HVAC module and secure with two screws. Using torque wrench, tighten screws to 20 lb-in (2.2 N·m). Proceed to Step 15.
- b) If Bergstrom Part Number is 1000326858-XX, LPM requires replacement. Proceed to Step 14.

14. If necessary, install new LPM to interior HVAC module and secure with two screws. Using torque wrench, tighten screws to 20 lb-in (2.2 N·m).
